EV FireSafe

Enhancing safety for emergency responders at **electric vehicle** fires

Emma Sutcliffe
Project Director

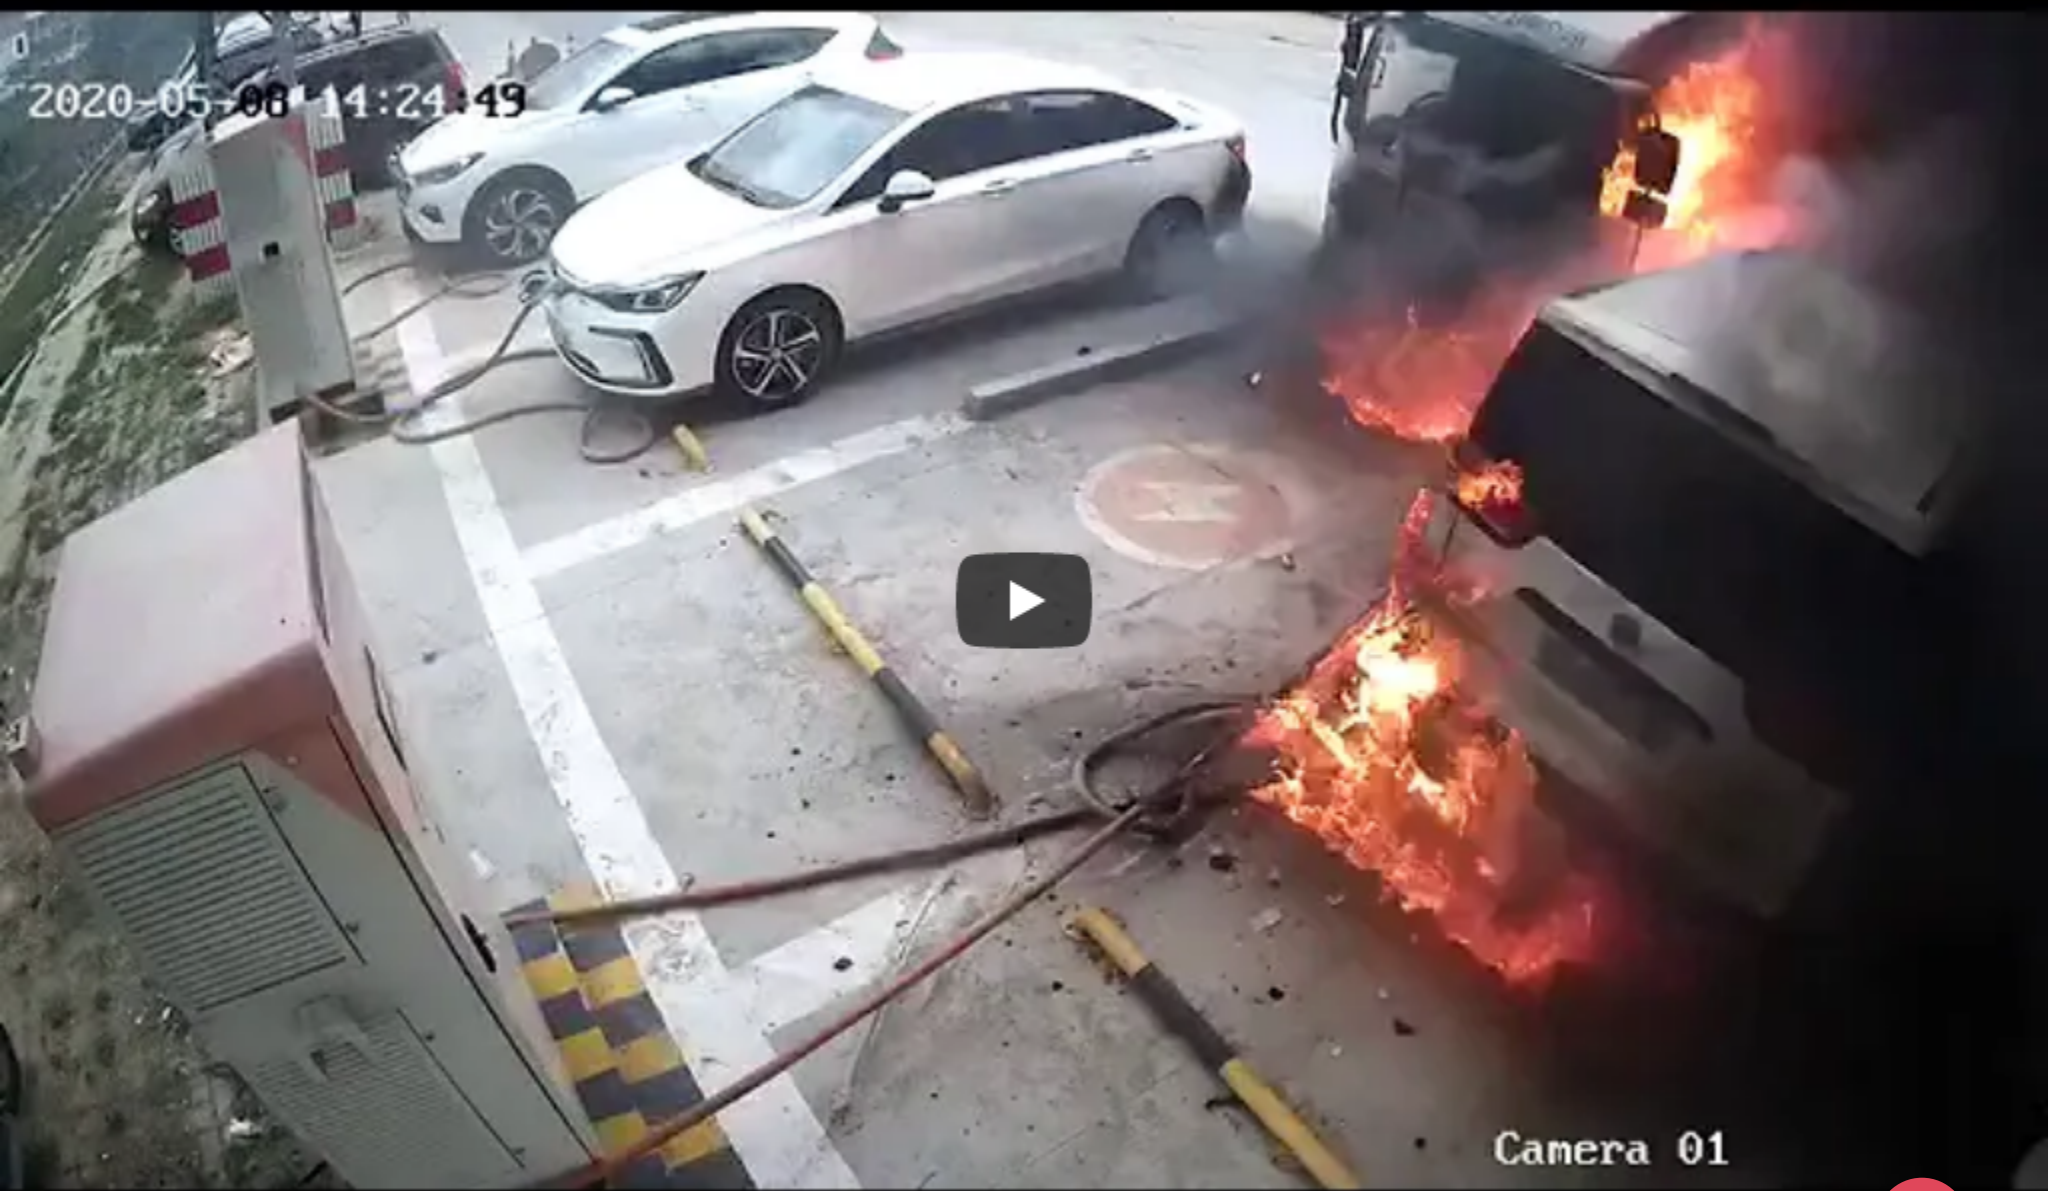
From an emergency responder perspective, thermal runaway looks & sounds like this

Dark **vapour** cloud,
light **vapour** cloud
(it's NOT smoke)

Popping - blast caps
Hiss/whistle - gas venting
Projectiles - cell debris

Ignition
Jet like, directional flames

Vapour cloud explosion
Violent deflagration

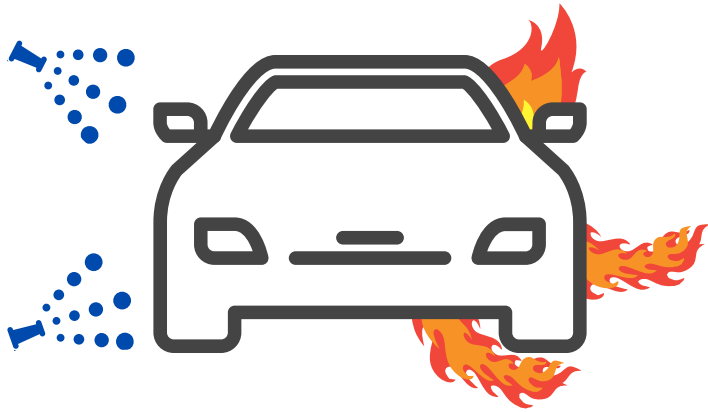
A stream of water onto the underside of the
EV will dissipate heat
= slow & stop thermal runaway
