# LiB & EV Fire Risk for Vicinity Centres

June 2023

**Prepared for:**  
Vicinity Centres

**Prepared by:**  
EV FireSafe  
Emma Sutcliffe, Project Director  
Dan Fish, Technical Specialist  
[evfiresafe.com](http://evfiresafe.com)

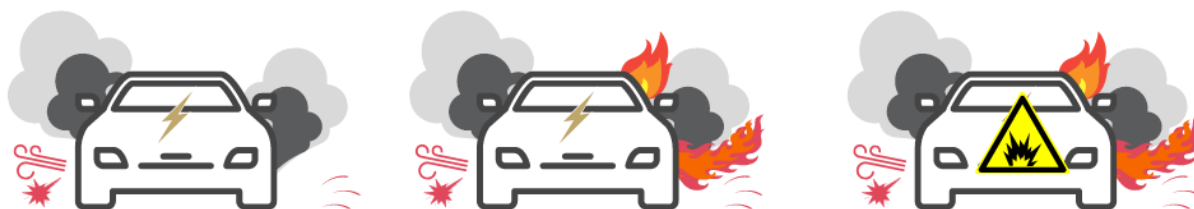
There are three primary hazards with lithium-ion batteries & electric vehicles:

- Off-gassing: toxic, flammable vapour clouds
- Ignition: vapour cloud ignites, creating a 'jet-like' flame
- Explosion: vapour cloud deflagrates, followed by ignition
